Cause and cost

Jeffrey Phillips, Hector Bourgeois and Ed Dougherty, Fern Engineering Inc., USA, consider the cause and low cost solution to blade fatigue in large centrifugal air compressors.

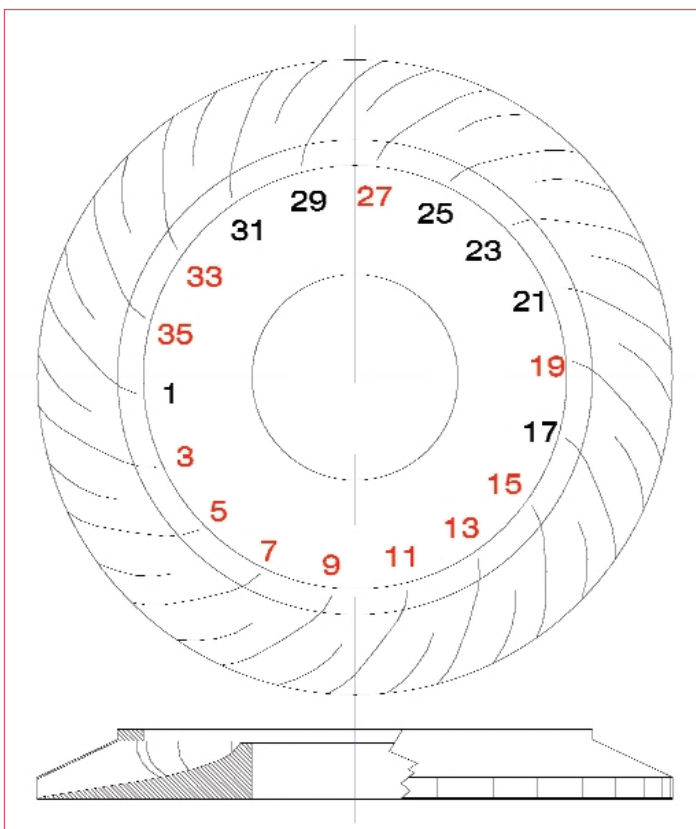
An inspection after a blade failure showed extensive fatigue induced cracking in blades on three of the four impeller stages. Additionally, on the fourth stage a portion of one blade was completely broken away, and 10 of the other 35 blades sustained damage, ranging from cuts in the leading edge (presumably from the break-away blade) to cracks up to 50 mm (2 inches) long. The equipment owner reported that the compressor had suffered more and more severe blade cracks since its uprating.

Figure 2. Diagram of the 35 blade fourth stage impeller.

Based on Fern's analysis, it was obvious that the natural frequency of the impeller blades needed to be increased to well above its current value. One way to accomplish this would be to rebuild the impeller with 50% thicker blades. This is the long term correction that GE adopted. However, because the air compressor was a critical piece of equipment in the owner's process, and because this approach requires a fairly long time to implement, an interim fix had to be found.

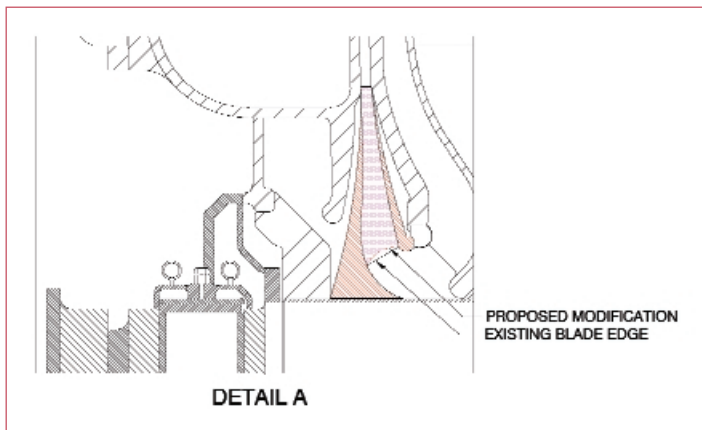
Figure 5. Drawing of the original impeller blade with Fern's recommended modification shown.

Fern's hardware design manager recommended that a small portion of the leading edge of each impeller blade be scalloped as indicated in Figure 5. In addition to increasing the natural frequency because of the configuration change, the newly rounded leading edge softens the effects of the upstream vane wakes since the wakes would be hitting the edge at slightly different times. The modification had the potential to degrade compressor performance slightly, but any degradation would be modest and was offset by the simplicity of the solution.

The recommended modification was quickly and easily implemented at GE's shop and the compressor was returned to service. Reports from the field indicated that no measurable degradation in performance could be observed, and no blade damage has been noticed since.

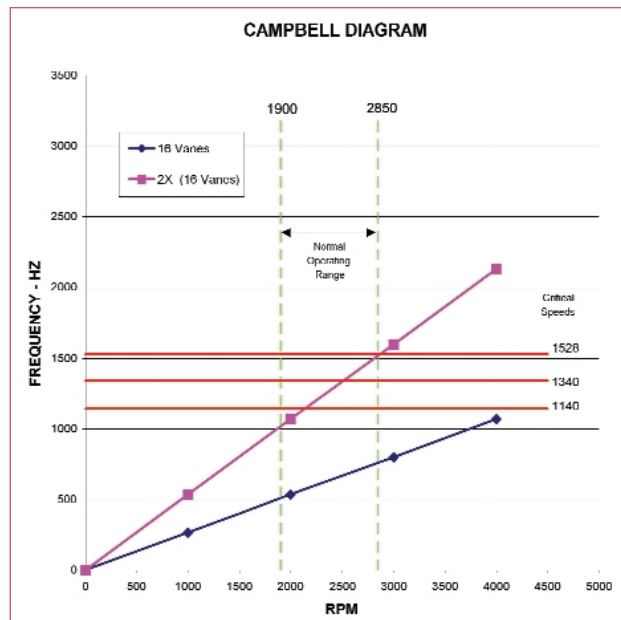
Figure 4. Campbell diagram showing relationship between impeller speed and the passing frequency of the vane wakes.

The relationship between the impeller rotating speed and the passing frequency of the vane wakes is presented in Figure 4. The diagram shows that if the impeller rotated at its lowest operating speed of 1900 rpm, each blade would pass a vane wake at a frequency slightly above 500 Hz, and if it rotated at its maximum speed of 2850 rpm, the passing frequency would be 760 Hz. These values are far below the measured natural frequency of the impeller or any of the other minor vibration peaks identified during the lab tests. The natural frequency and the other peaks are shown nominally by the horizontal lines in the Campbell diagram.

However, it is important to also look at multiples of the passing frequency, since hitting a wake at exactly every other cycle of the natural frequency of the impeller will also excite the blades. It can be seen in the Campbell diagram that the 2X line (the equivalent of having 32 vanes) in the region of the normal compressor operating

speeds does intersect the frequencies where subordinate vibration peaks were measured and comes close to the lower natural frequency measured on the damaged impeller.

Taking into account the fact that the hotter metal temperatures would have lowered the natural frequency below the levels measured in the lab and that a forcing function does not have to be exactly on the natural frequency to induce significant vibrations, it was concluded that wakes from the inlet vanes probably did excite the natural frequency of the impeller and lead to the eventual failure by fatigue.
