Low Cost Multiplane Balance of a Gas Turbine Auxiliary Driveshaft

A compressor train at an Amerada Hess Corporation plant suffered from serious vibration. The staff of Fern Engineering developed a low-speed balancing procedure to solve the problem, at a fraction of the cost of high-speed balancing.

Hector Bourgeois, Fern Engineering
Scott Haines, Amerada Hess Corp

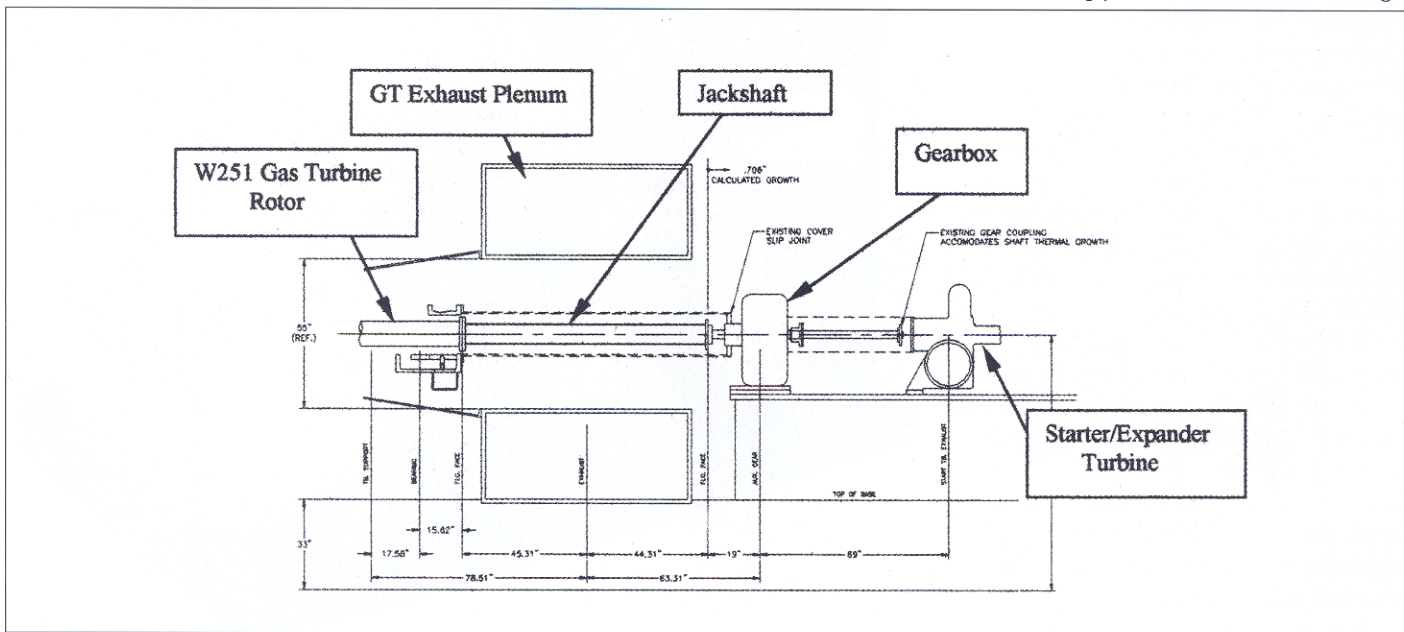
The long jackshaft is 89 inches long

Fig. 1. Starter drive train, viewed from the side.

x 7 1/2 inches in diameter, with one end solidly bolted to the aft end to the gas turbine shaft and the other end solidly bolted to the input side (pinion shaft) of the gearbox. The pinion shaft goes straight through the gearbox case with no gear ratio change to an output side. The pinion shaft has no thrust bearings so that it is free to move back and forth. The smaller gear-coupling shaft is solidly bolted to the output end of the pinion shaft, and the gear coupling end is connected to the expander turbine. The purpose of the gear coupling is to accommodate the large accumulated thermal growth of the entire gas turbine and starter train shafting.

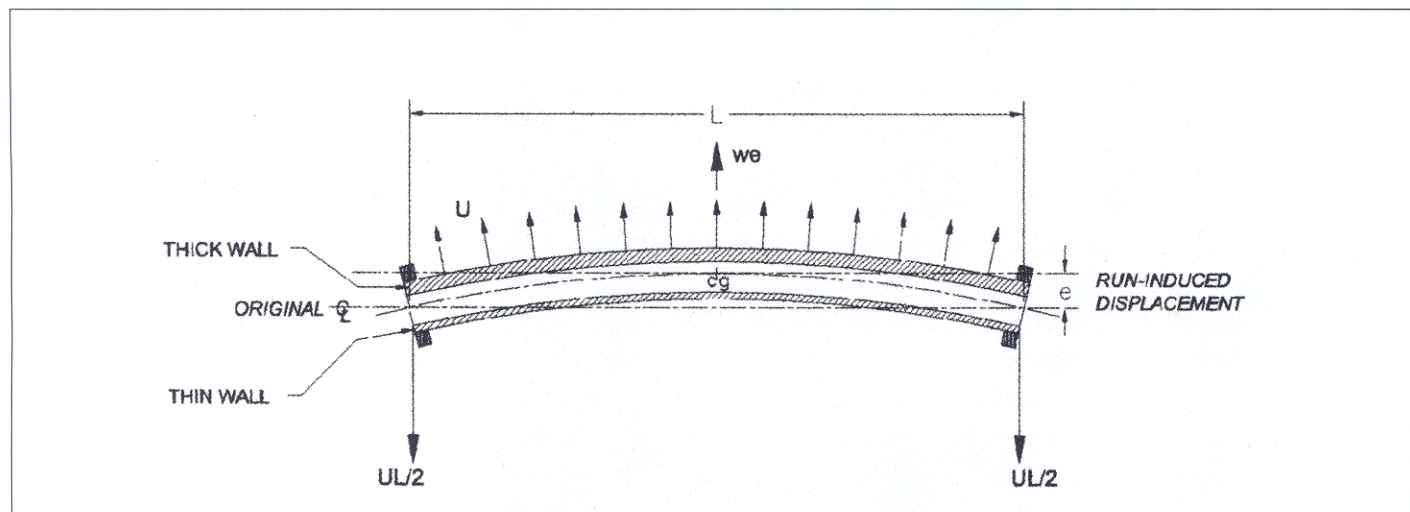
In a conventional balancing procedure, balance weights that compensate for the inherent unbalance are placed on the ends of the shaft. This placement of the balance weights is adequate, providing that the shaft operating speed is close to the balancing speed, or the shaft is considered a compact shape. However, with long, slender shafts that operate at speeds much higher than the balance speed, conventional balancing is inadequate. Because the balance weights are lumped at the shaft ends instead of being distributed along the shaft length directly opposing the unbalance, the shaft will deflect as in a simply supported beam with a distributed load, as shown in Figure 2.

Deflection of the shaft will occur as the speed increases beyond the balance speed, with the deflection being proportional to the square of the speed. At high speeds this deflection becomes significant. As a result, the

Fig.2. Shaft deflection due to an unbalance condition.

displaced center of gravity of the shaft creates a run-induced or deflection induced unbalance.

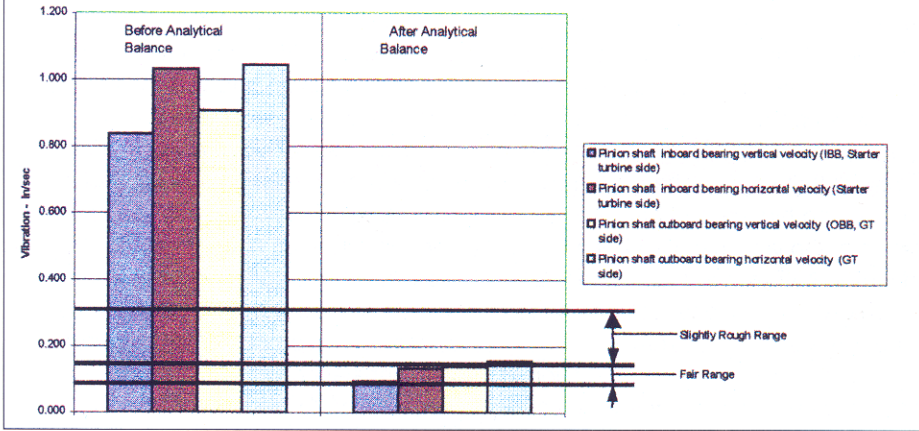
Jackshaft Vibration

Fig.3. Jackshaft vibration levels, before and after balancing.

Vibration measurements taken before and after showed a major reduction of 90% in vibration levels. Figure 3 shows a side-by-side comparison of vibration levels before and after balancing. ■

The corrective procedure involves defining three planes along the shaft tube (1/4 span, 1/2 span and 3/4 span) and measuring the wall thickness and run-out around the circumference at equal

clock positions in these planes. Polar plots of the measurements are then made, and the associated center of gravity (cg) offset and its clock position are then calculated for each plane. This cg offset times the weight of shaft length (1/4 shaft tube) that it represents equals the unbalance. A compensating weight is then placed in that plane to negate the inherent unbalance. A final trim balance is then conducted at conventional

balance speeds with those balance weights placed at the shaft ends in the normal manner.
