Cause and cost

Jeffrey Phillips, Hector Bourgeois and Ed Dougherty, Fern Engineering Inc., USA, consider the cause and low cost solution to blade fatigue in large centrifugal air compressors.

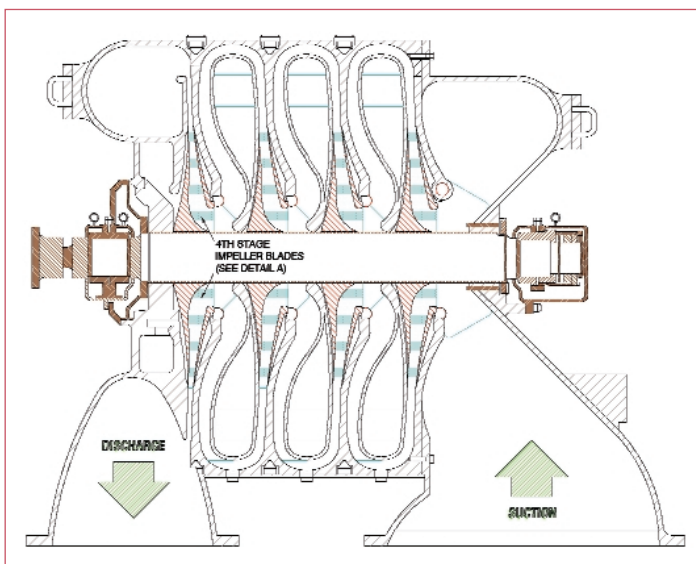
An inspection after a blade failure showed extensive fatigue induced cracking in blades on three of the four impeller stages. Additionally, on the fourth stage a portion of one blade was completely broken away, and 10 of the other 35 blades sustained damage, ranging from cuts in the leading edge (presumably from the break-away blade) to cracks up to 50 mm (2 inches) long. The equipment owner reported that the compressor had suffered more and more severe blade cracks since its uprating.

Figure 1. Outline drawing of the compressor showing the four impeller stages.

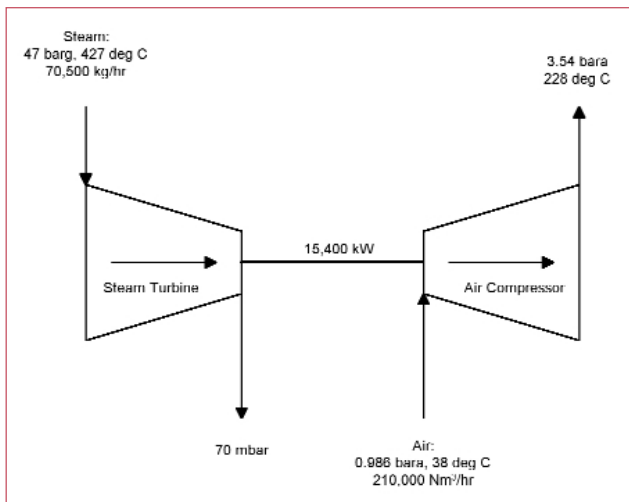
The compressor is driven by a steam turbine with a design operating speed of 2660 rpm, however, during normal operations the speed varies between 1900 and 2850 rpm. The design operating conditions of the turbine compressor train are shown in Figure 3.

Figure 3. Design operating conditions of the steam turbine air compressor train.
