Gas turbine fuel nozzle refurbishment

Follow these guidelines to improve reliability and reduce emissions

J. N. PHILLIPS and P. SIMAS, Fern Engineering, Inc., Pocasset, Massachusetts

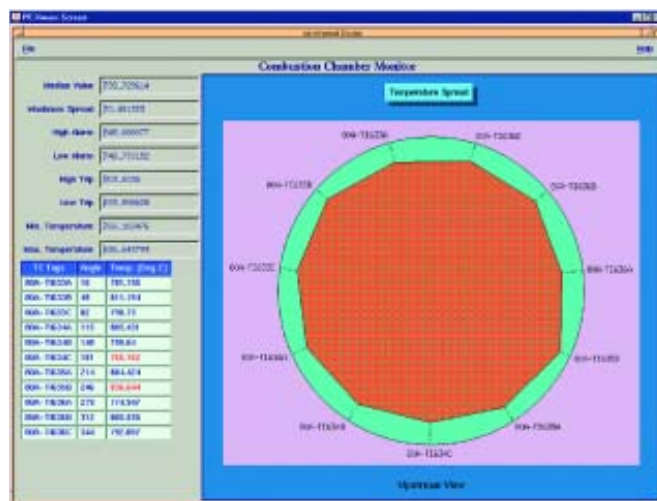
FIG. 2. Example of a combustion monitor graphical output.

Gas turbine performance monitoring software has now developed to the point that it can calculate the amount of swirl in the flow and rotate the position of the exhaust thermocouples to indicate the location of the fuel nozzle that produced the flow passing by each thermocouple.¹ An example of the graphical output from this type of analysis is shown in Fig. 2.

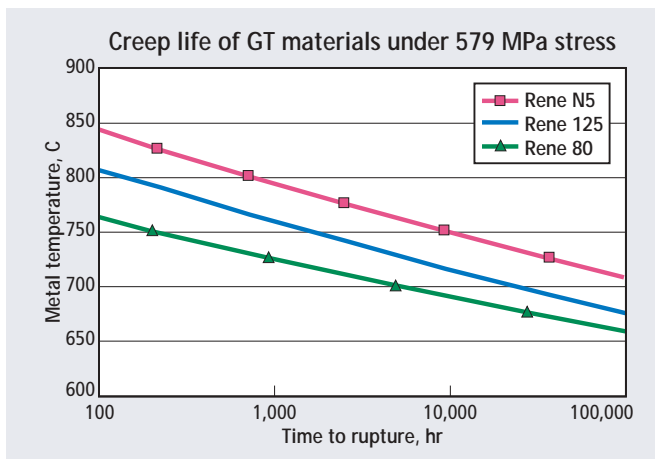
FIG. 3. Creep life of metal components is extremely sensitive to metal temperature.

Creep life of metal components in the hot section of a gas turbine is extremely sensitive to metal temperature. Fig. 3 shows the relationship between metal temperature and creep life of several materials typically used in gas turbine hot sections. Note that a temperature increase of only 50°C will reduce the materials' life by an order of magnitude.

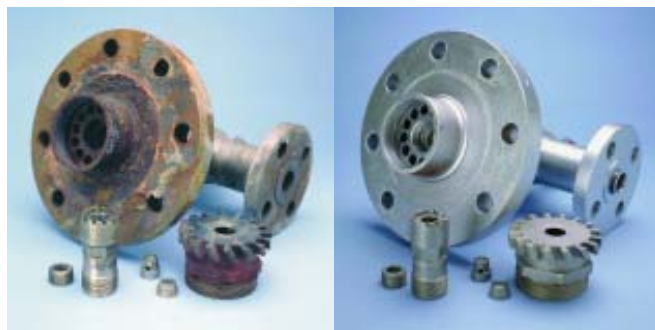
FIG. 4. A disassembled fuel nozzle before (left) and after (right) refurbishment.

When a set of fuel nozzles is removed for testing and refurbishment, it should be put through a multistep process called for in OEM maintenance protocols. During the process, each nozzle is disassembled, cleaned and inspected. Any worn-out parts are repaired or replaced, and the nozzles are rebuilt, flow tested and calibrated to ensure uniform flow. Typical "before" and "after" photos of refurbished fuel nozzles are shown in Fig. 4. A key step in the process is the inspection, which can help in the problem diagnosis. For example, many combustion problems can be diagnosed by examining the wear patterns on the nozzles.

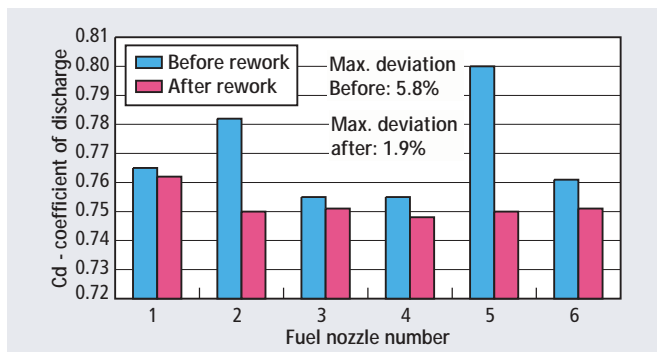
FIG. 5. After cleaning and refurbishment of the flow passages, the deviation in C_d was less than 2%.

Case study. A West Coast refinery was experiencing excessive temperature spreads in the exhaust of its gas turbines. It sent their fuel nozzles to a lab for testing and refurbishment. Upon receipt, each nozzle was flow tested to confirm whether the nozzles were providing uniform flow. As shown in Fig. 5, the flow discharge coefficients, C_d , of the nozzles—an indication of the flow delivered for a given supply pressure—deviated by almost 6%. After cleaning and refurbishing the flow passages, the deviation in C_d

was less than 2%. Once the reworked fuel nozzles were reinstalled in the gas turbine, the temperature spread was reduced to 22°C (40°F) versus an average of 72°C (130°F) before refurbishment. The cause and effect were obviously identified.
